U.S. Department  
of Transportation

National Highway  
Traffic Safety  
Administration

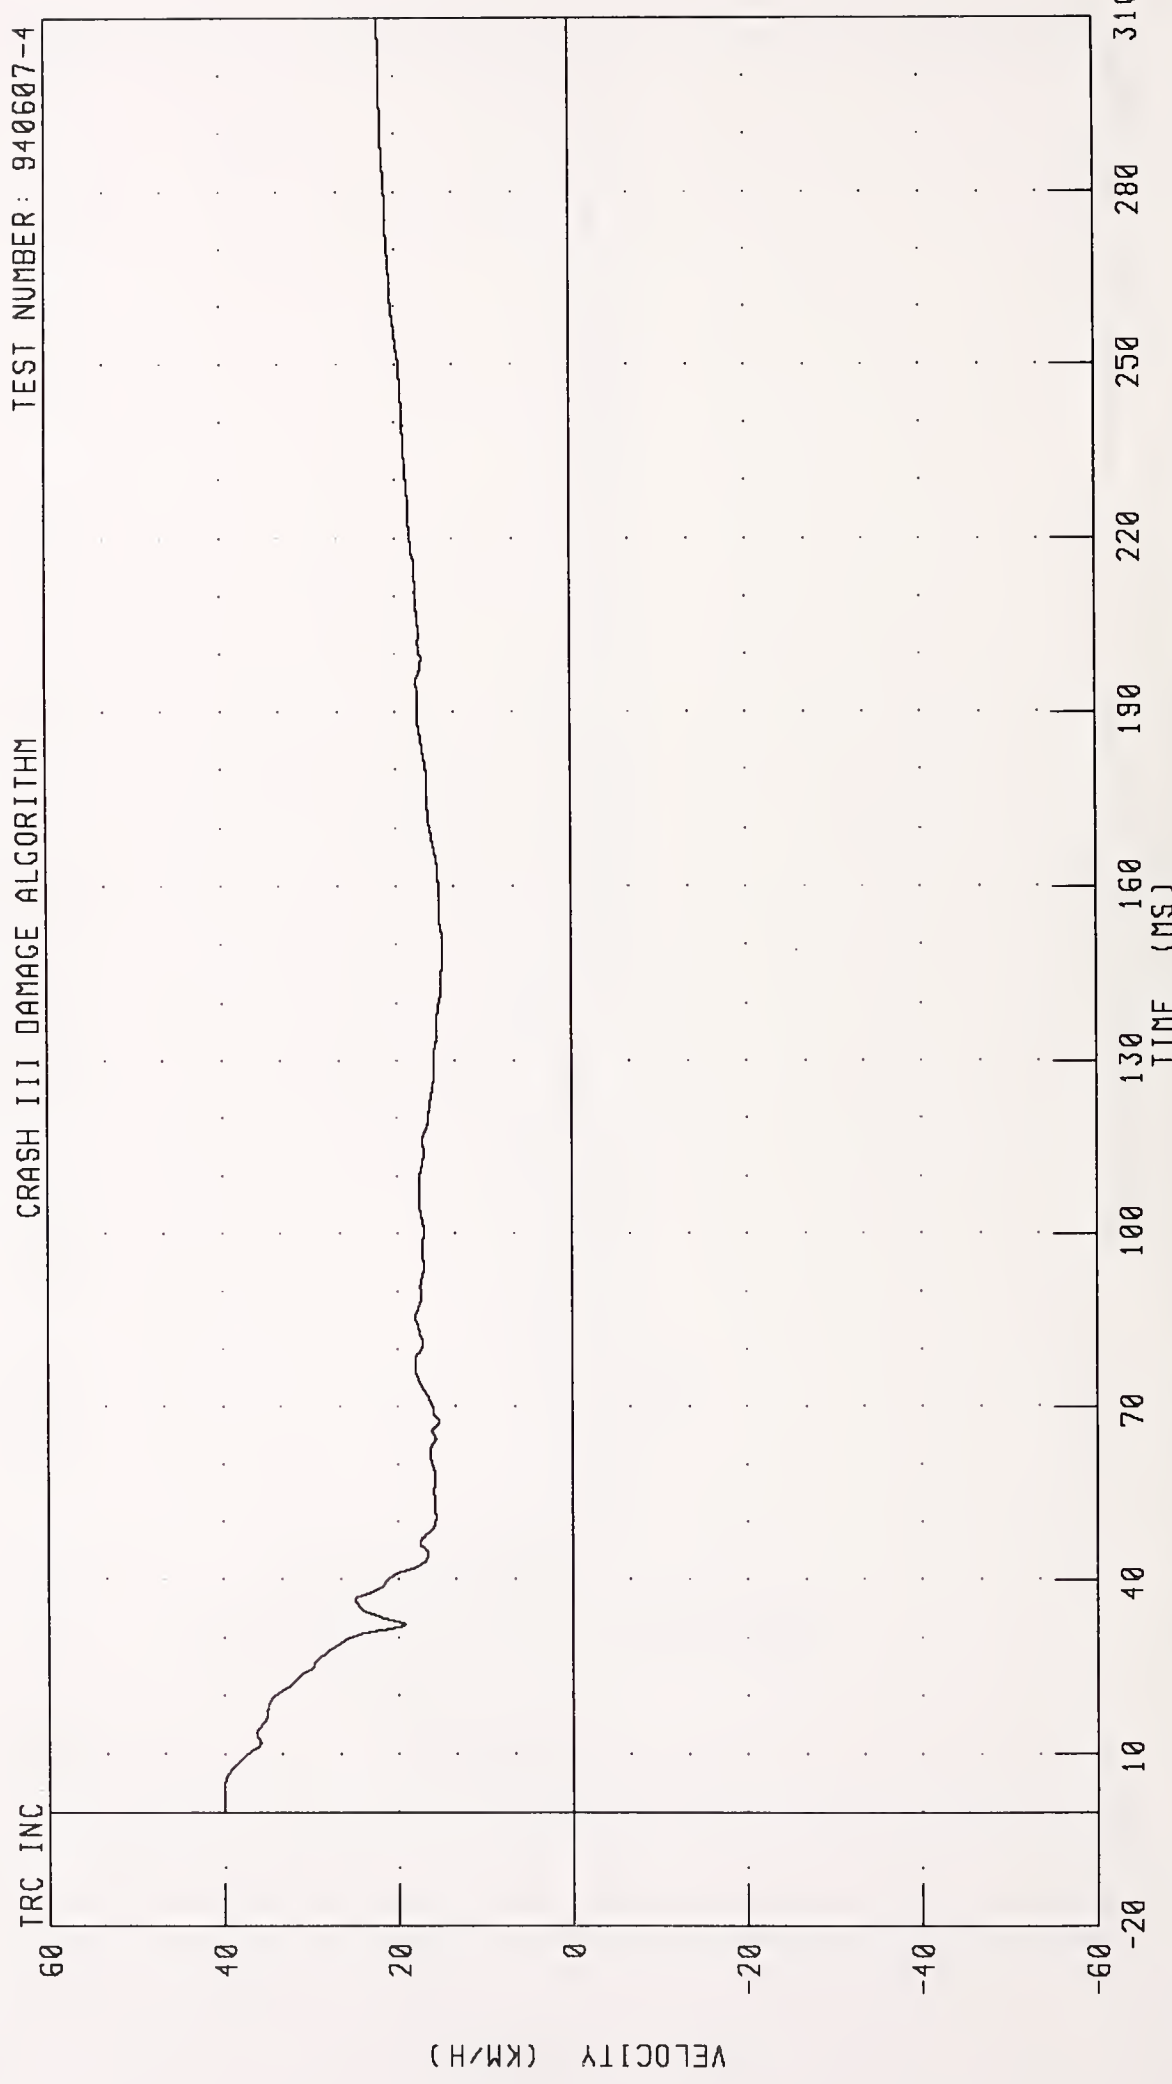
CHANNEL: VCGXV1 FILTER: CH. CLASS 180 PEAK DATA: 39.94 KM/H @ 3.76 MS; 14.67 KM/H @ 148.72 MS

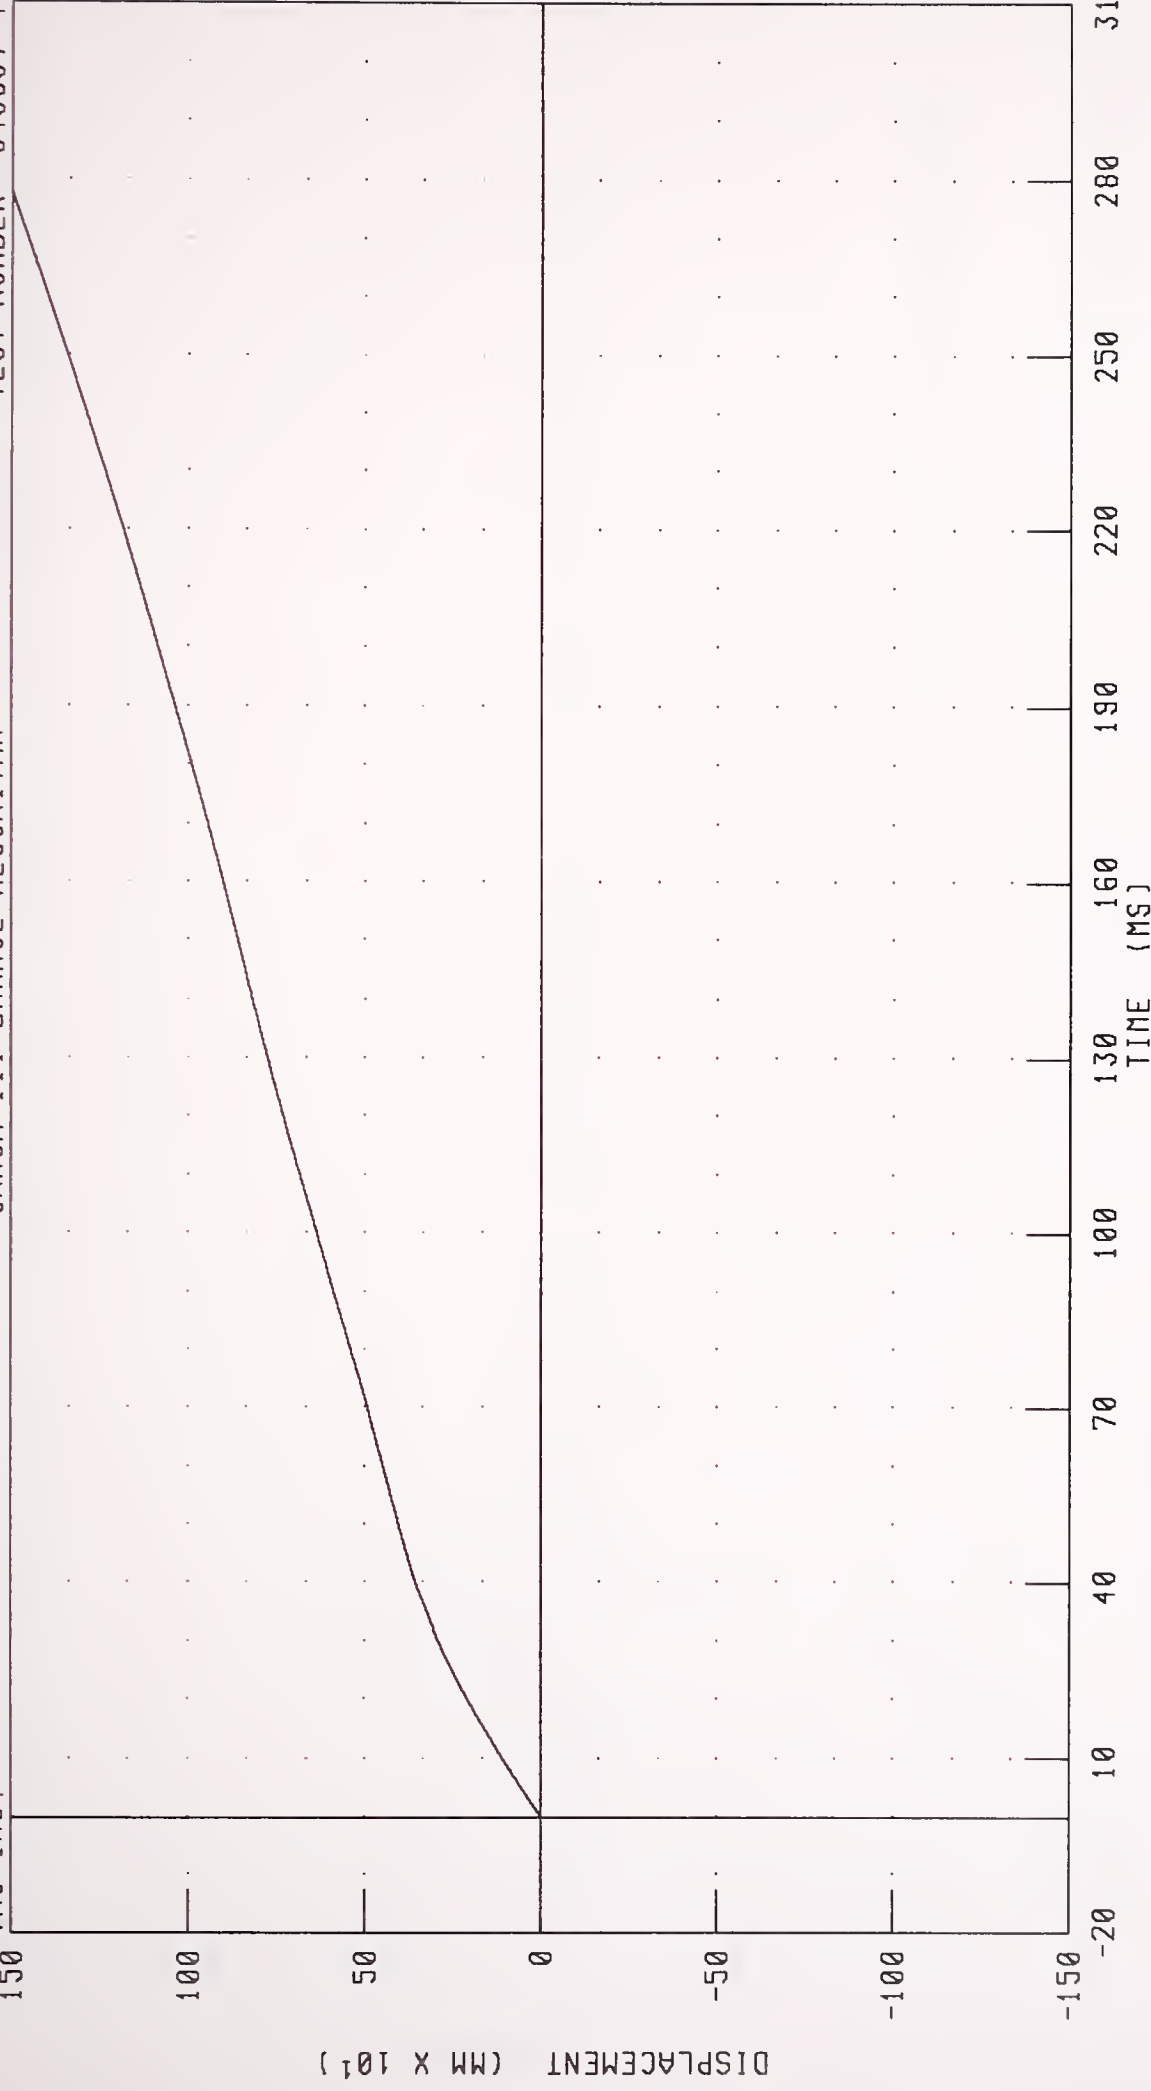
CHANNEL: VCGXD1 FILTER: CH. CLASS 180

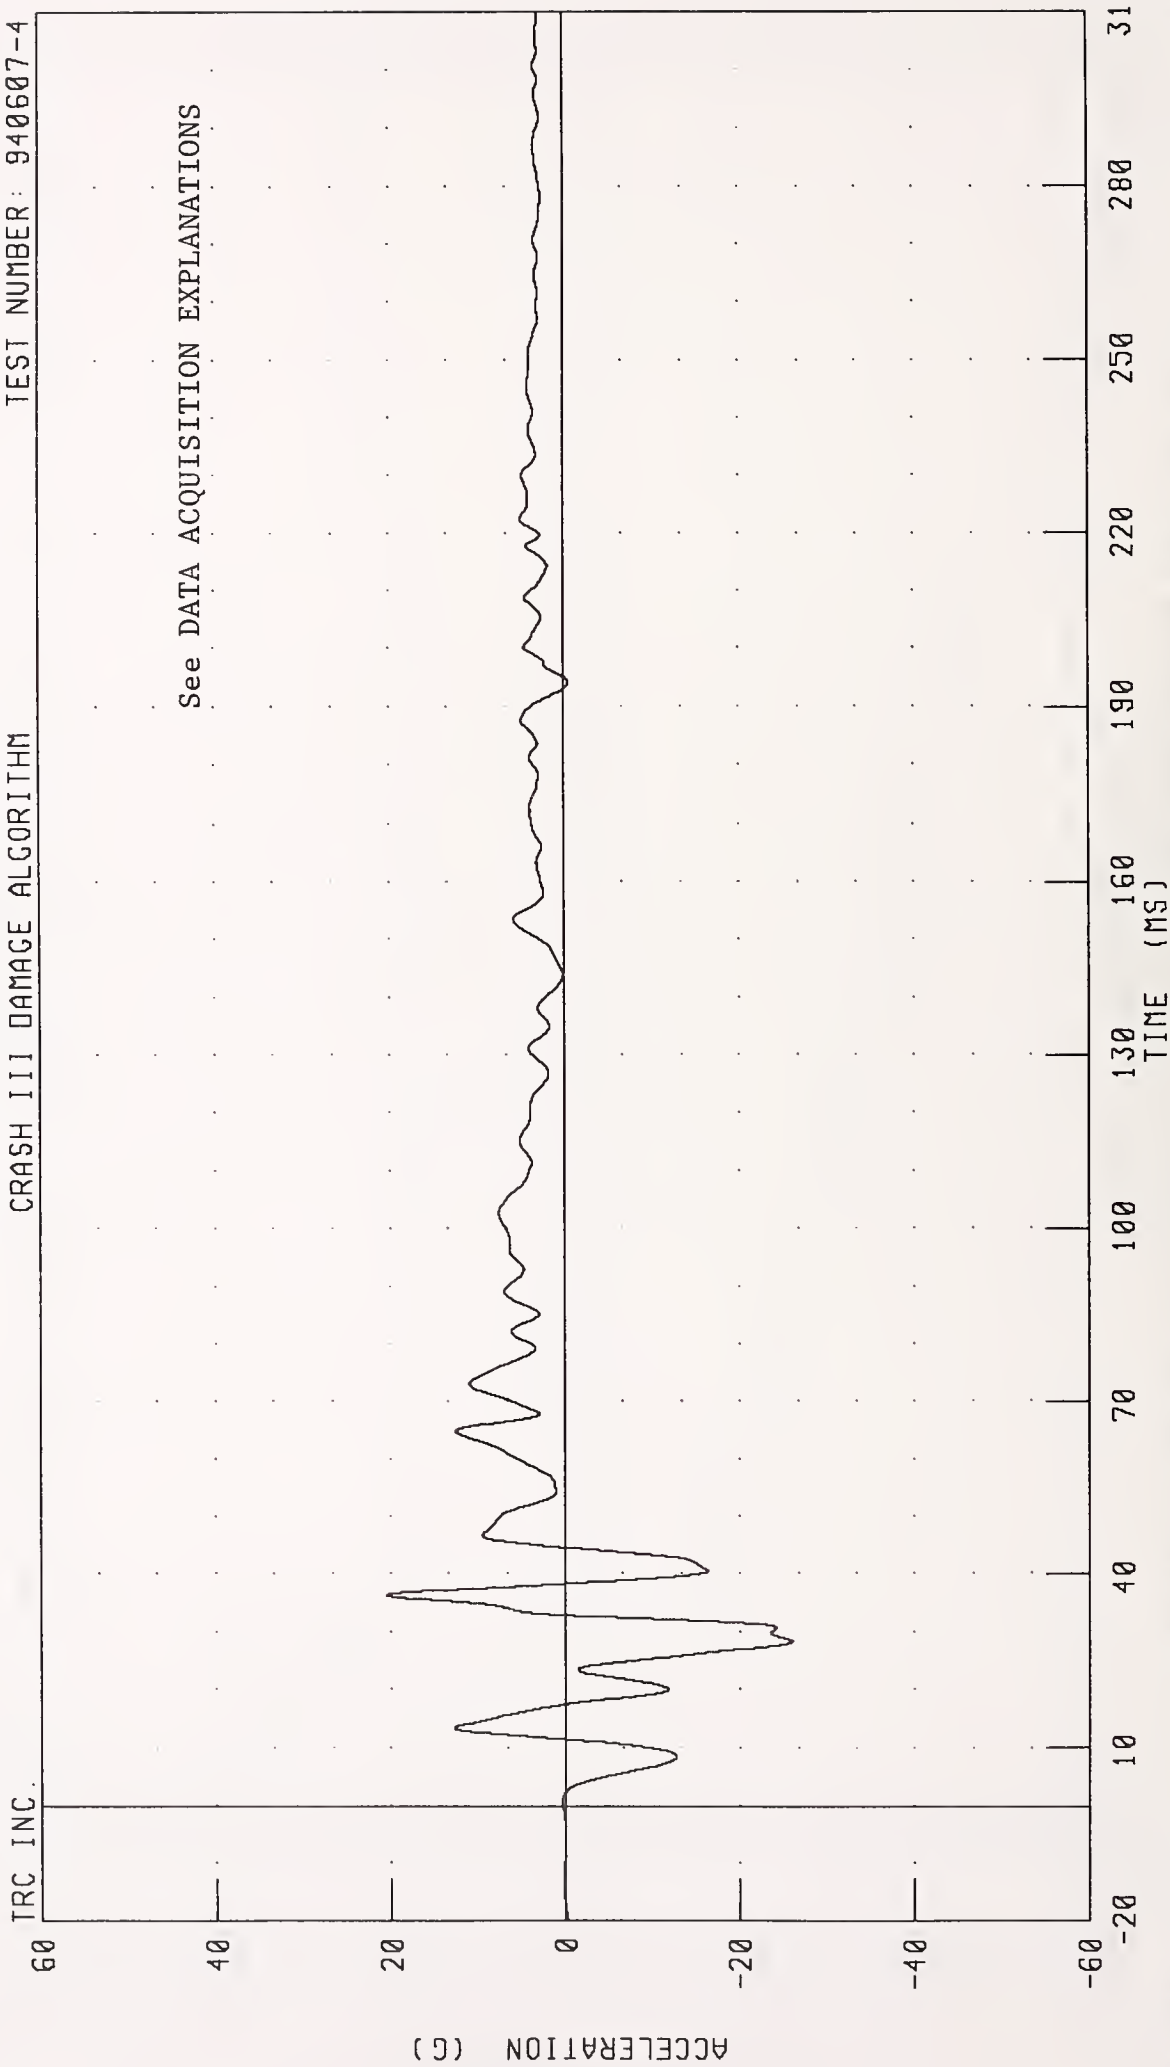
CHANNEL: VCGYG1 FILTER: CH. CLASS 60

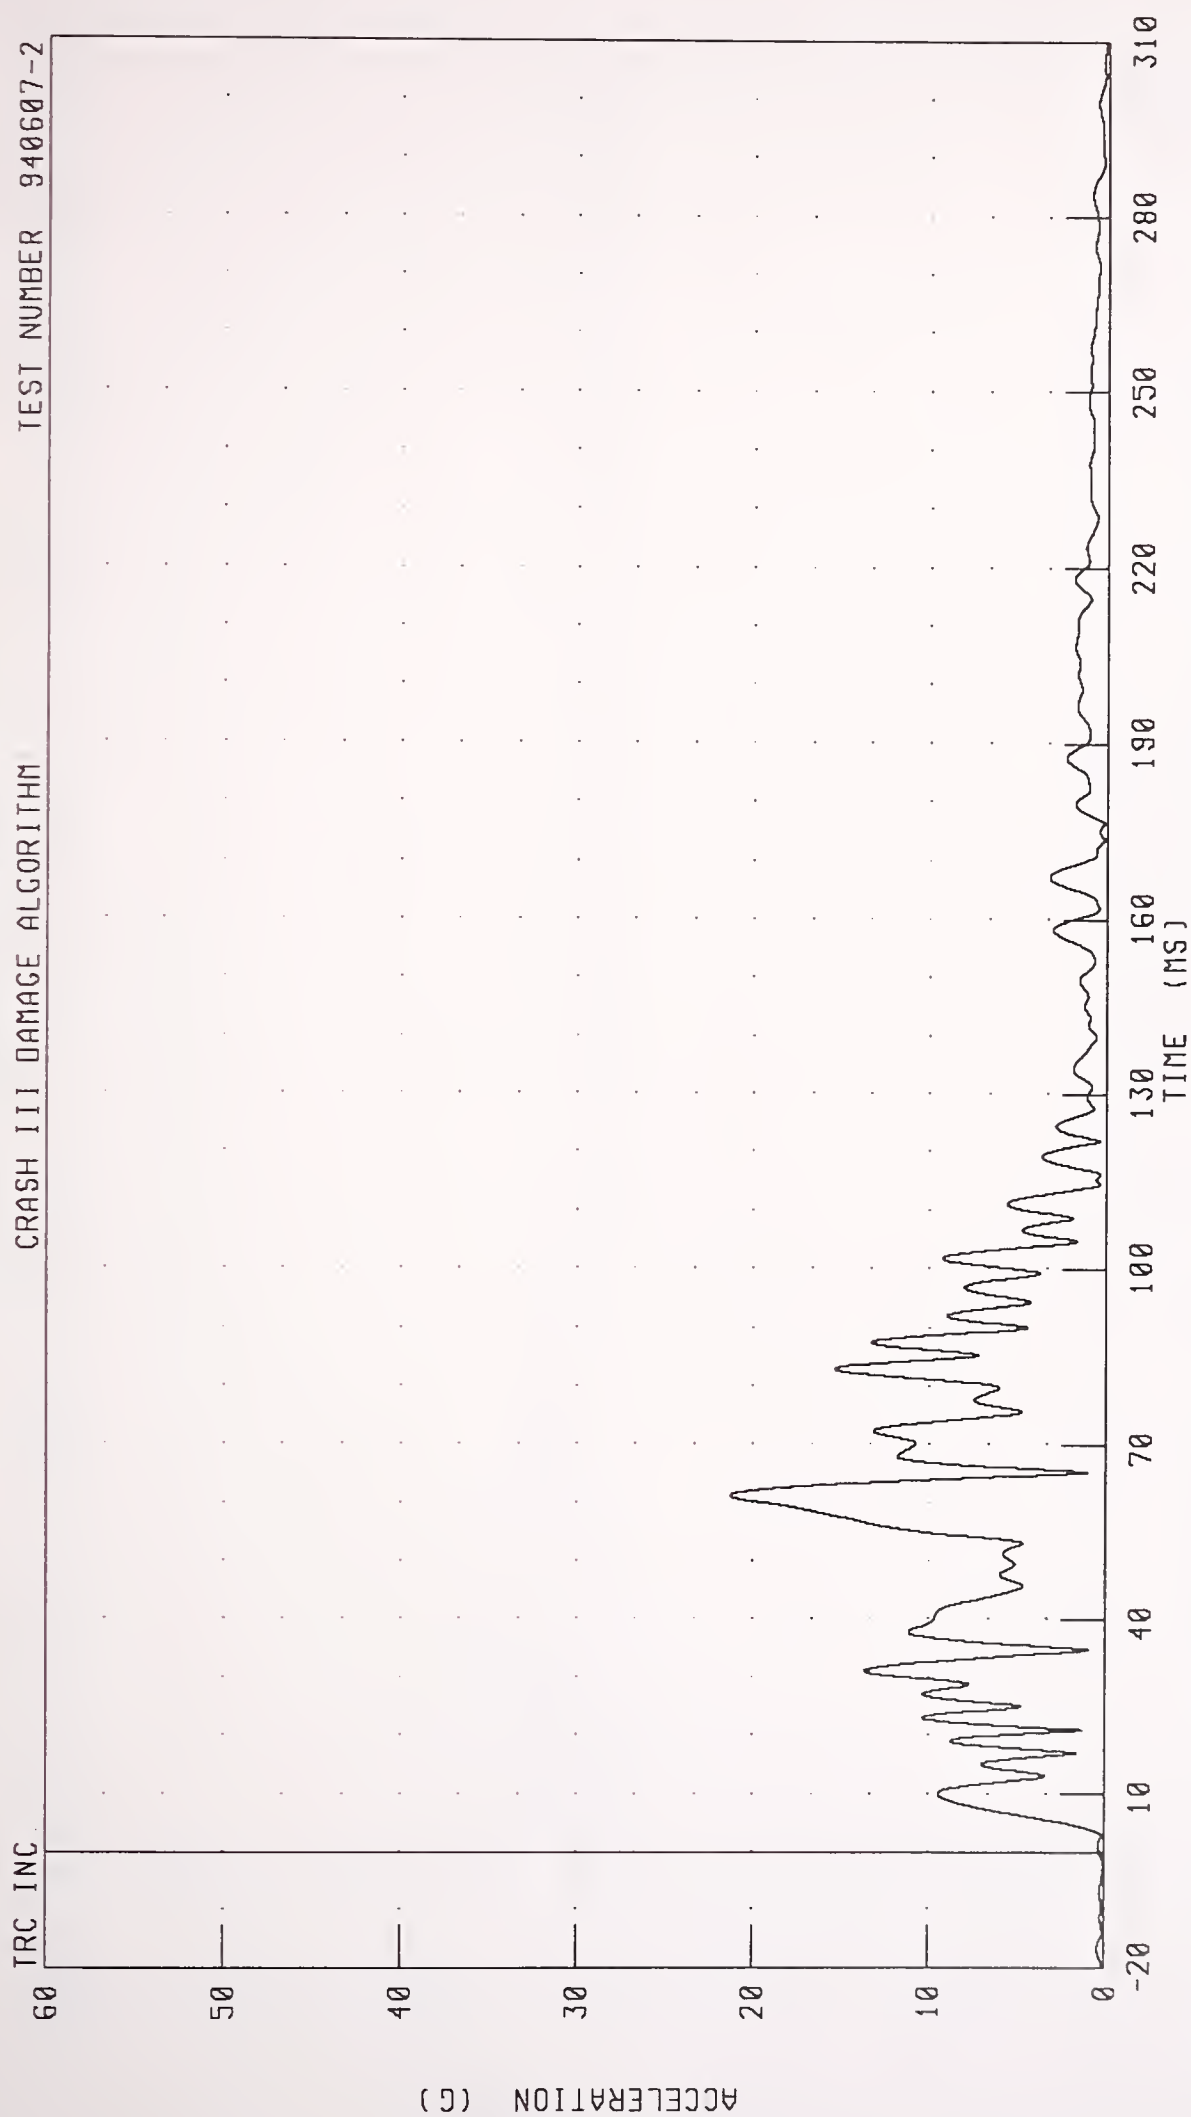
CHANNEL: VCGRG1 FILTER: CH. CLASS 60

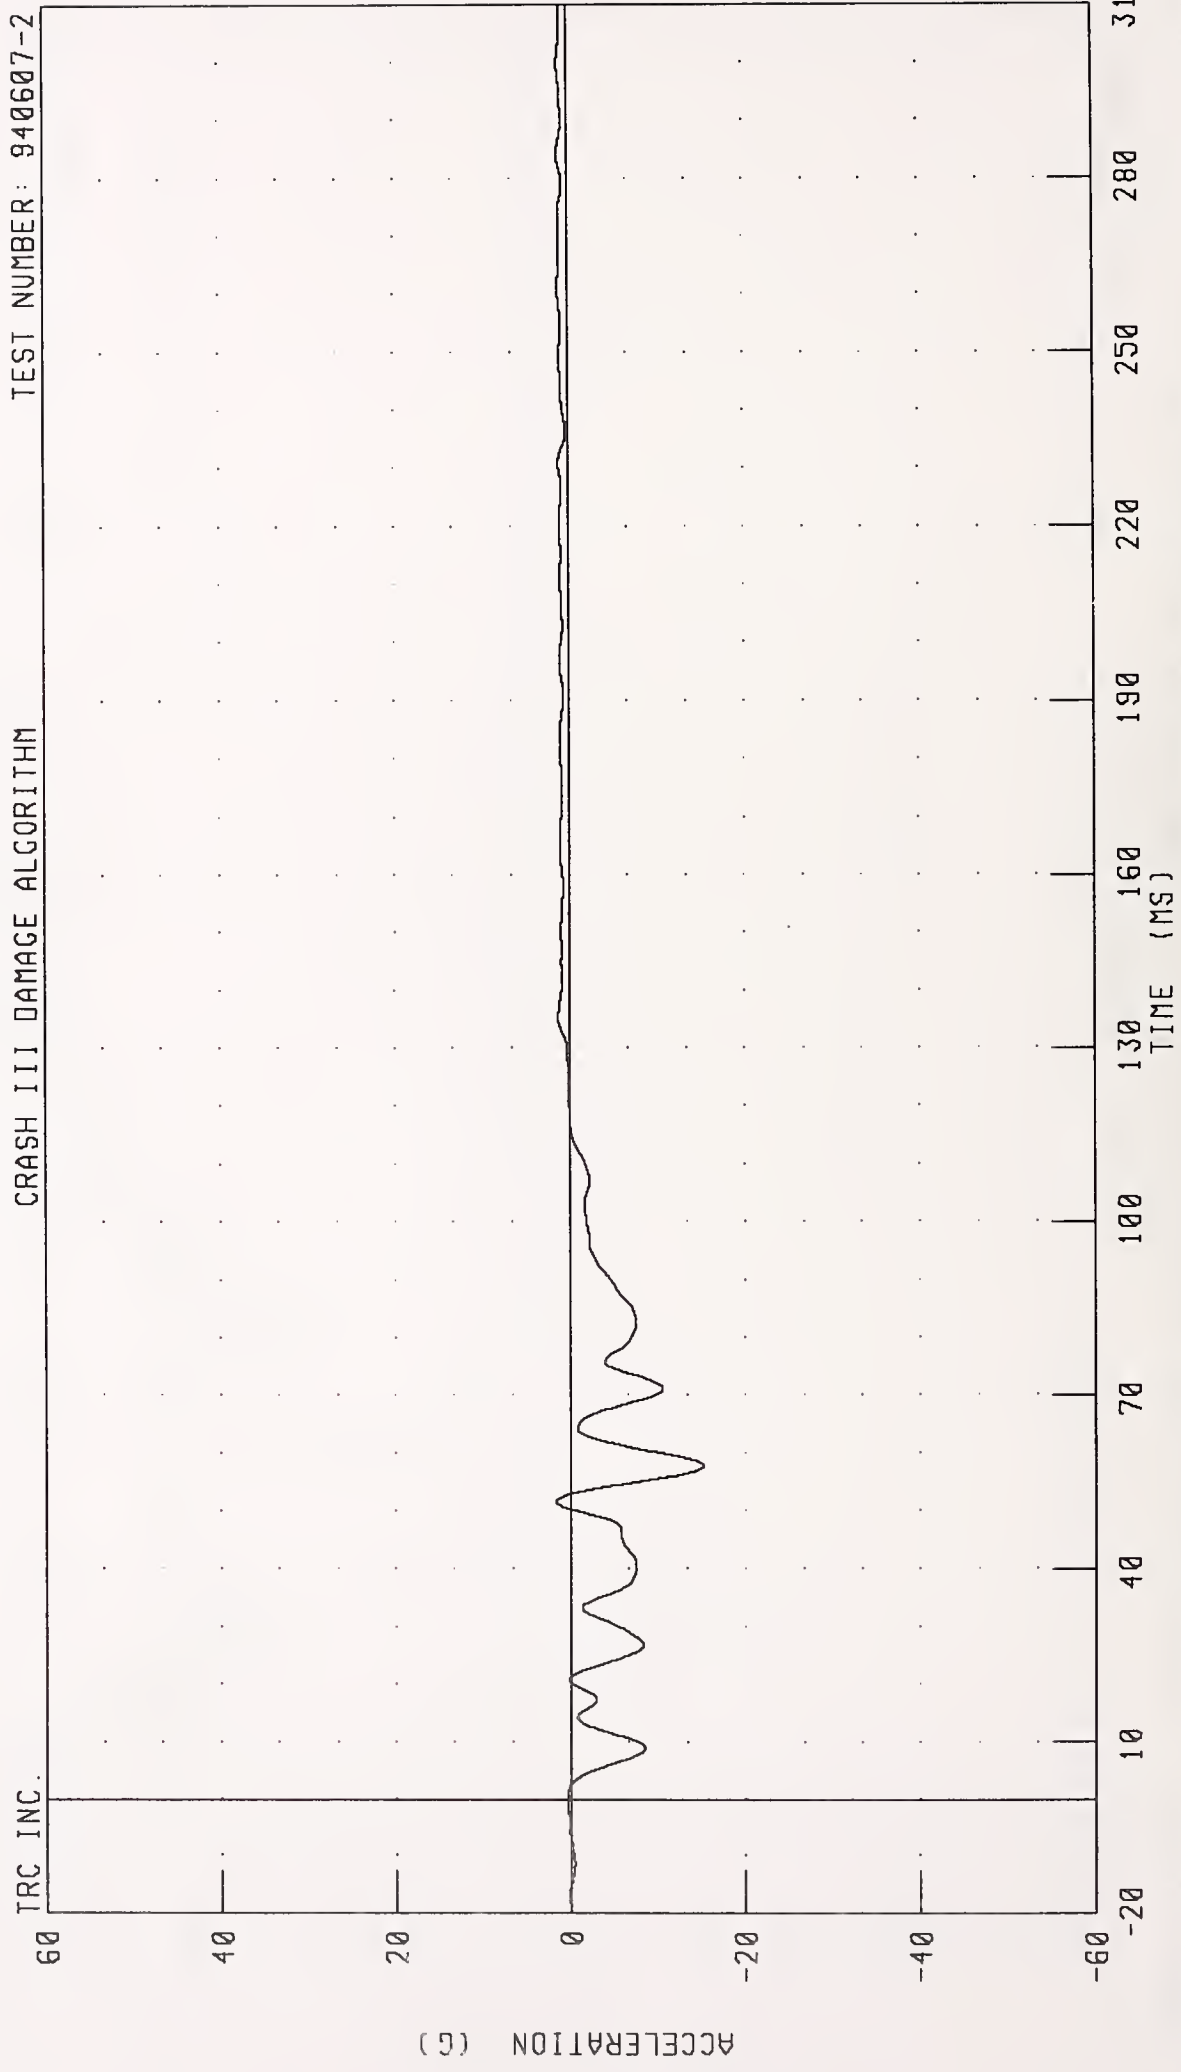
CHANNEL: LRSXG1 FILTER: CH. CLASS 60

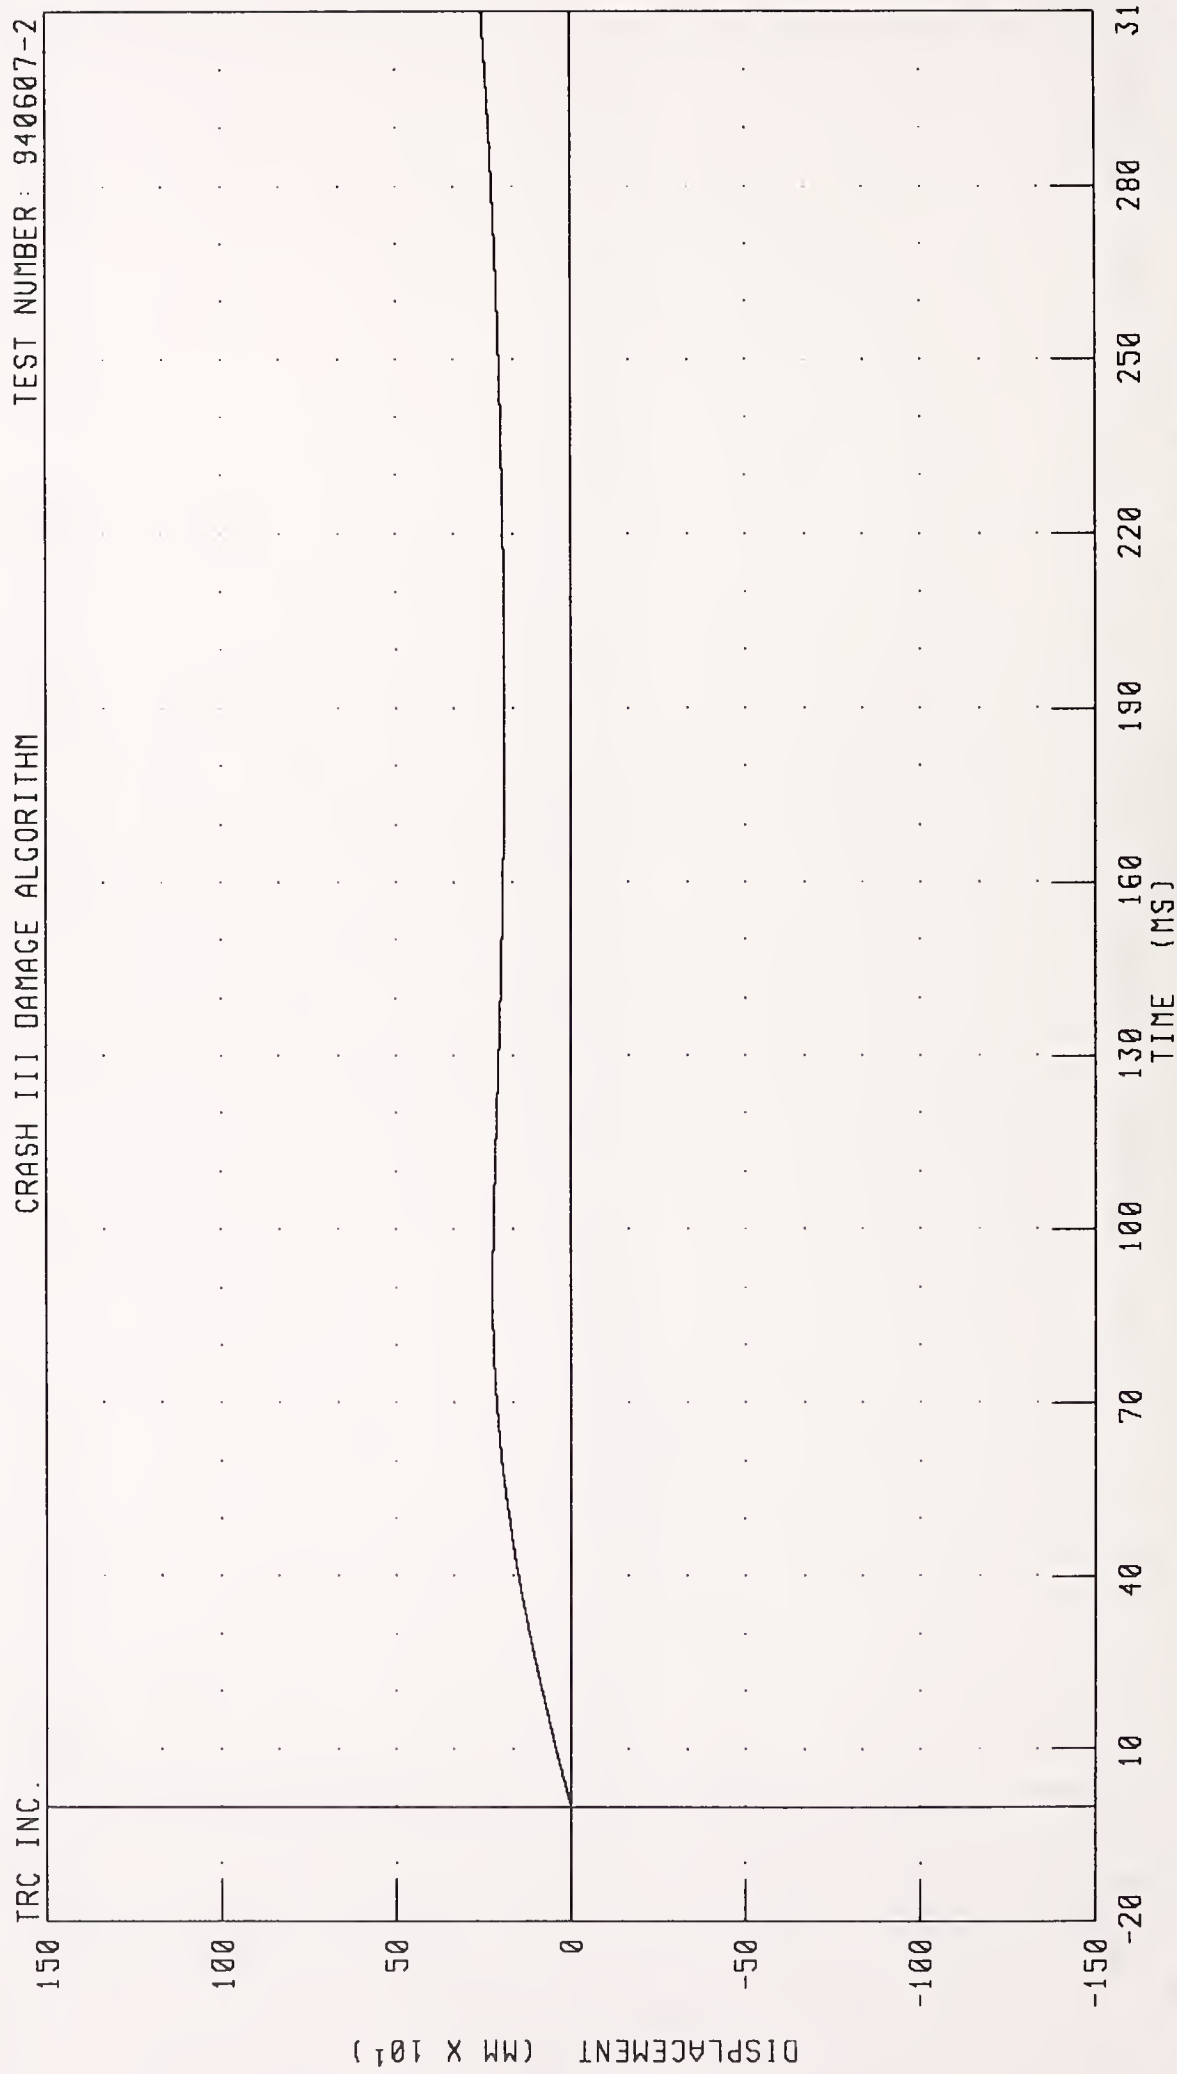
CHANNEL: LRSXD1 FILTER: CH. CLASS 180

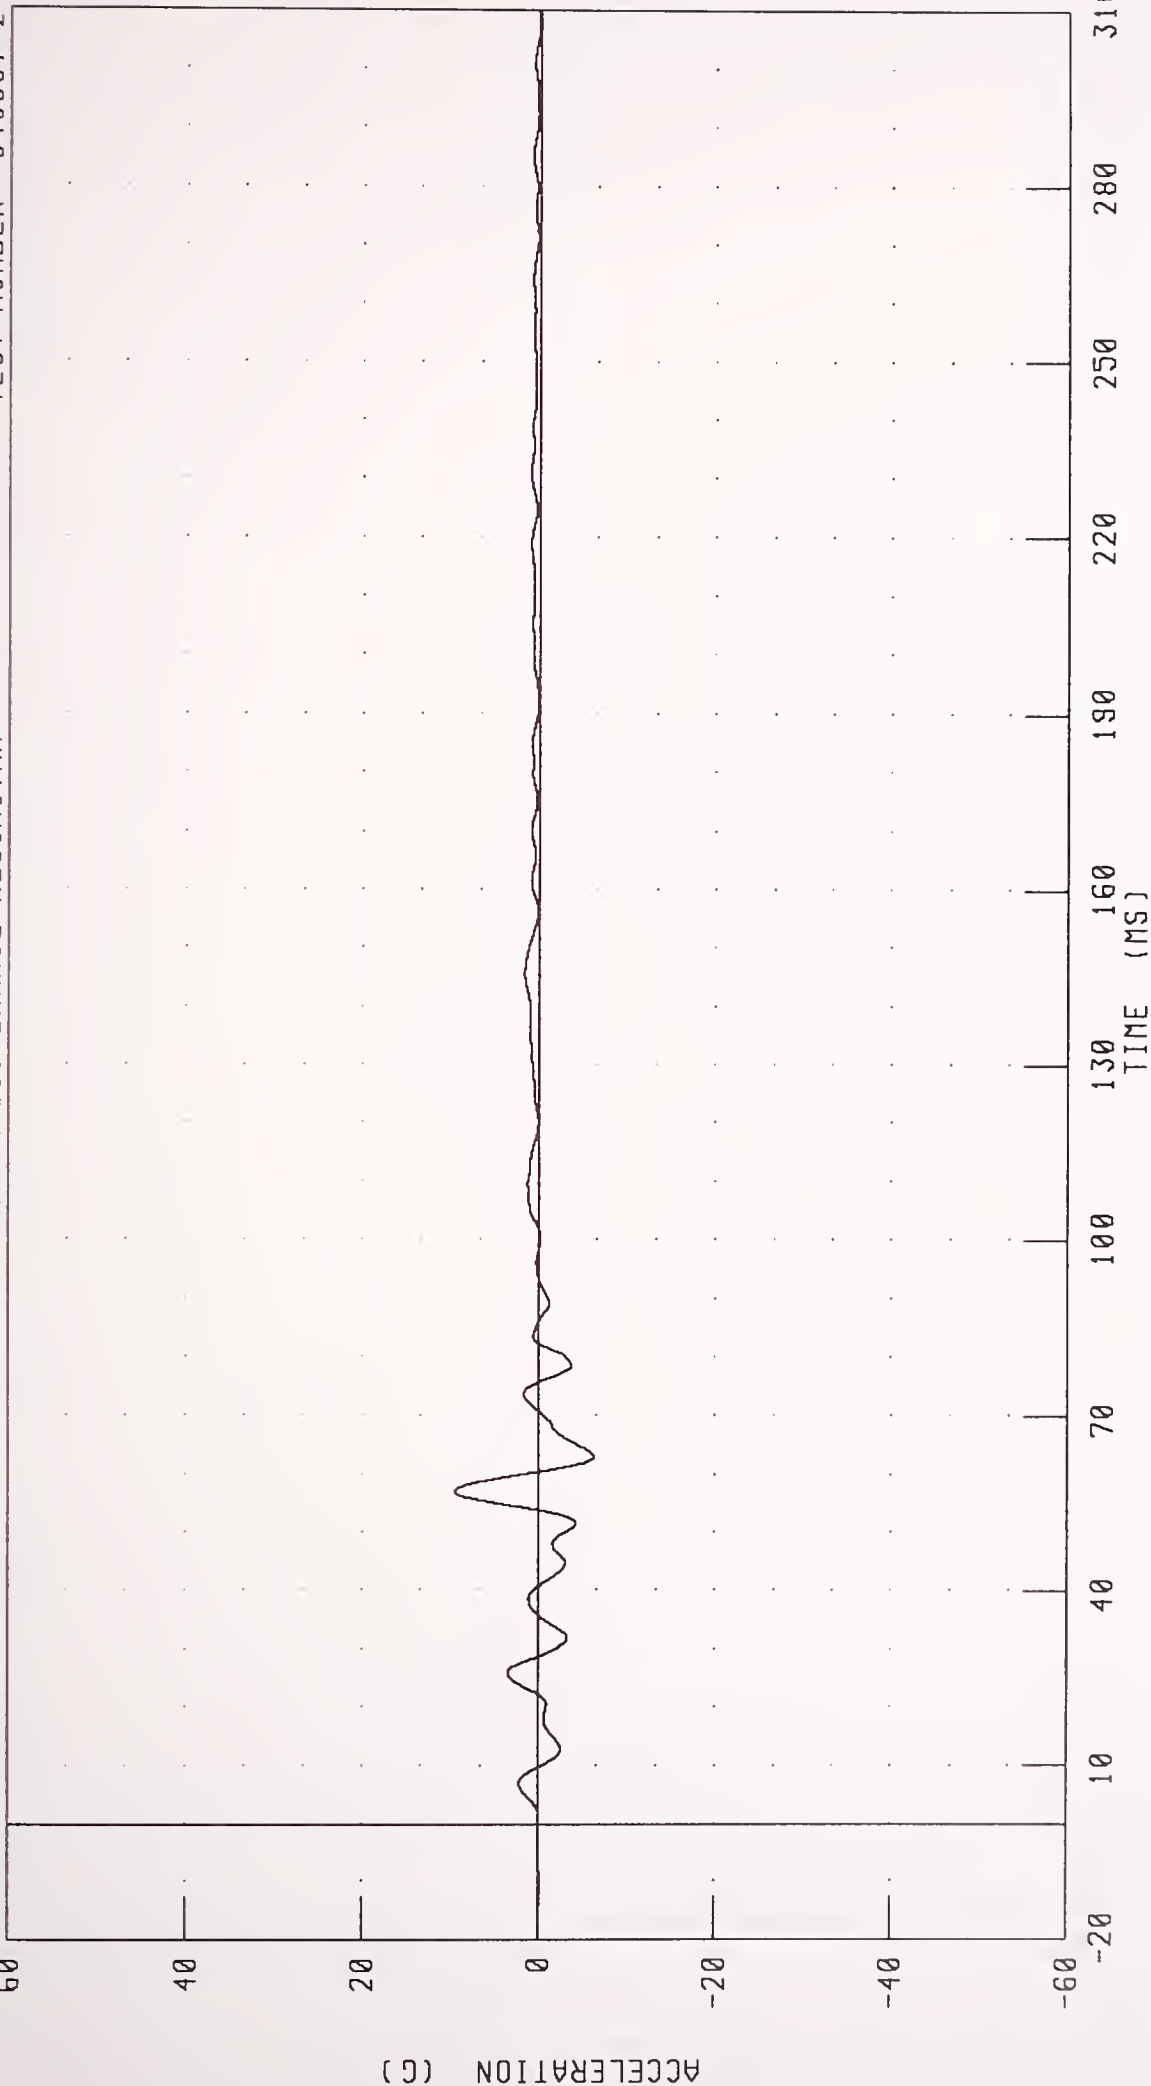
CHANNEL: LRSYG1 FILTER: CH. CLASS 60

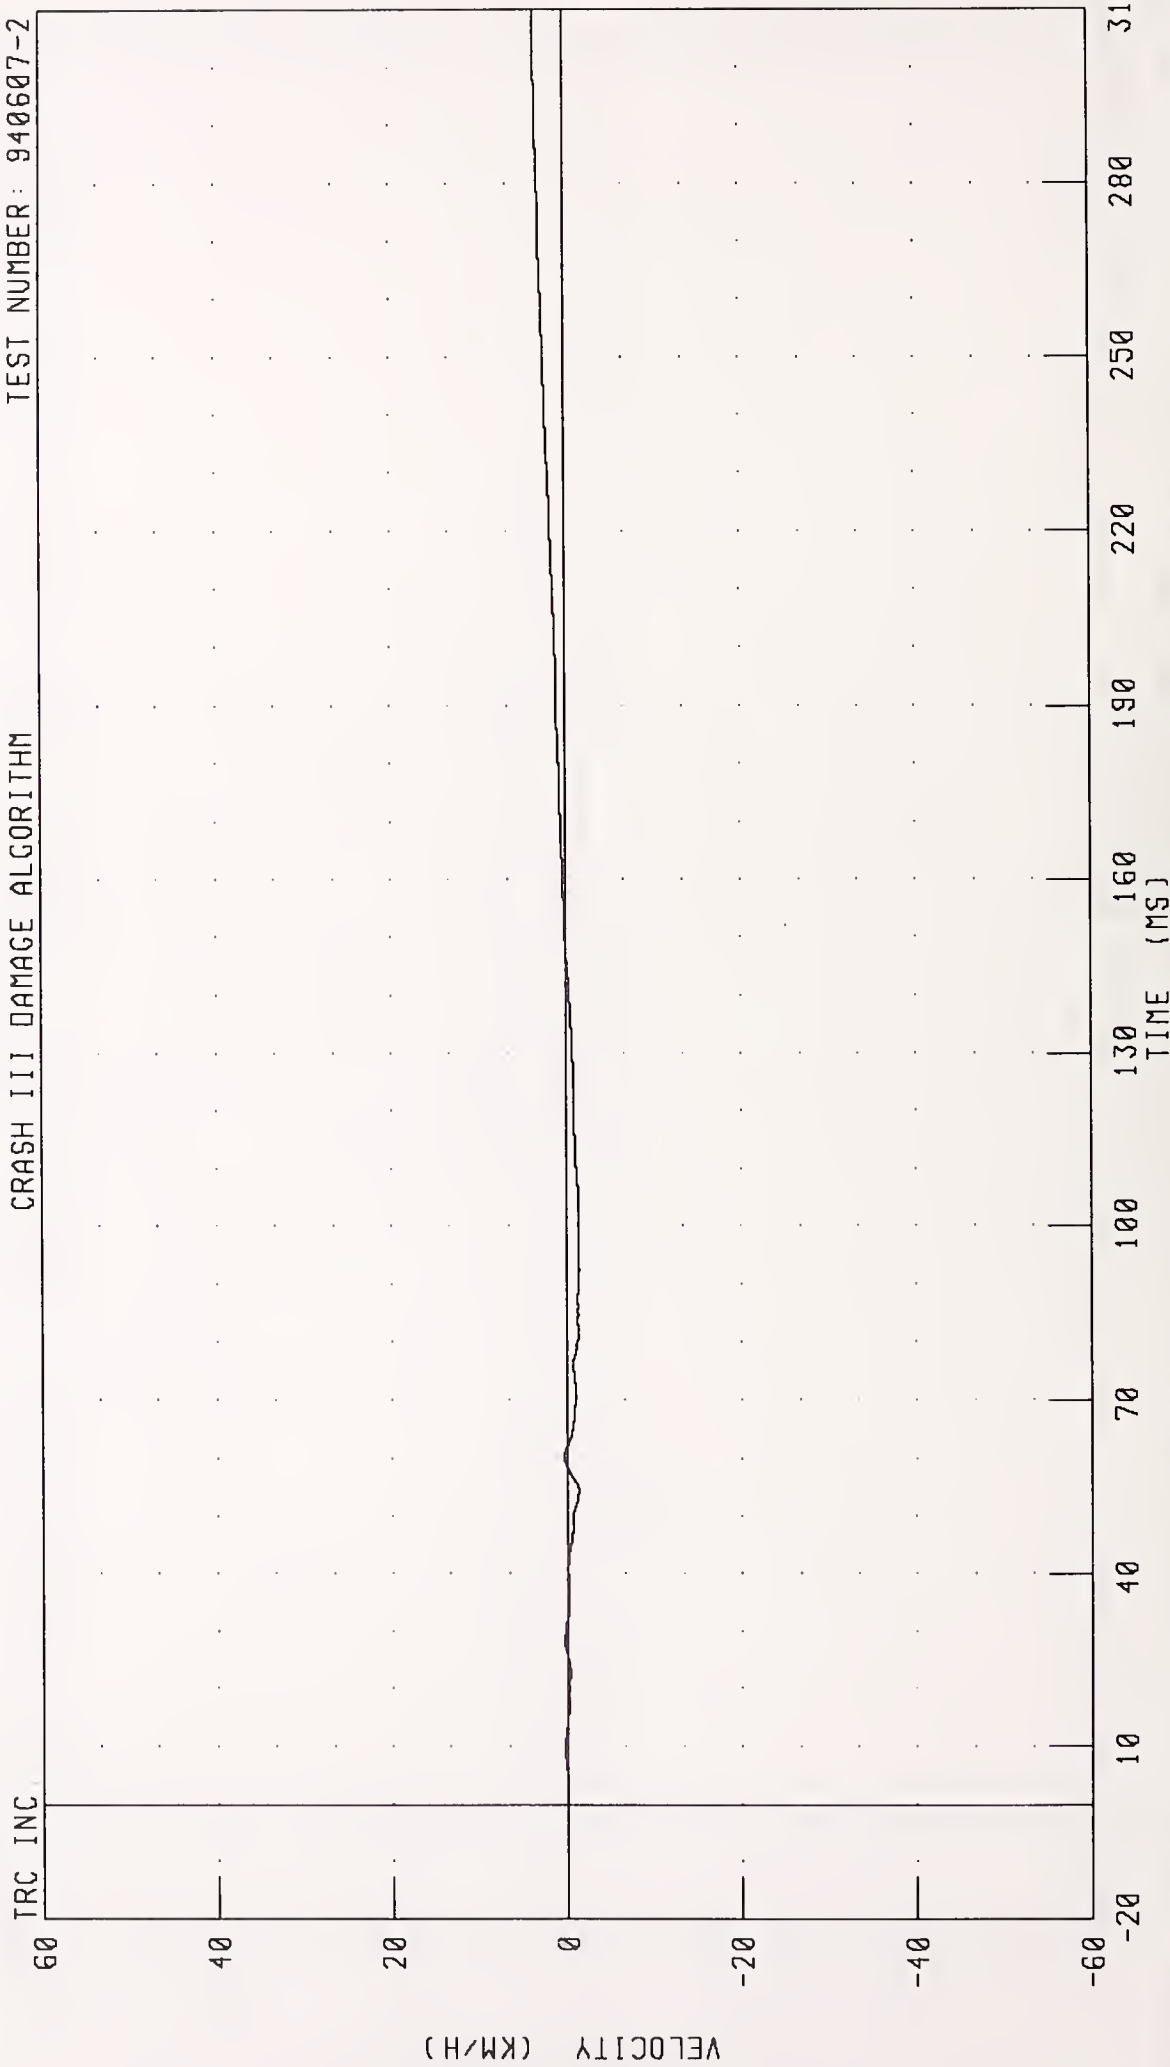
CHANNEL: LRSYV1 FILTER: CH. CLASS 180

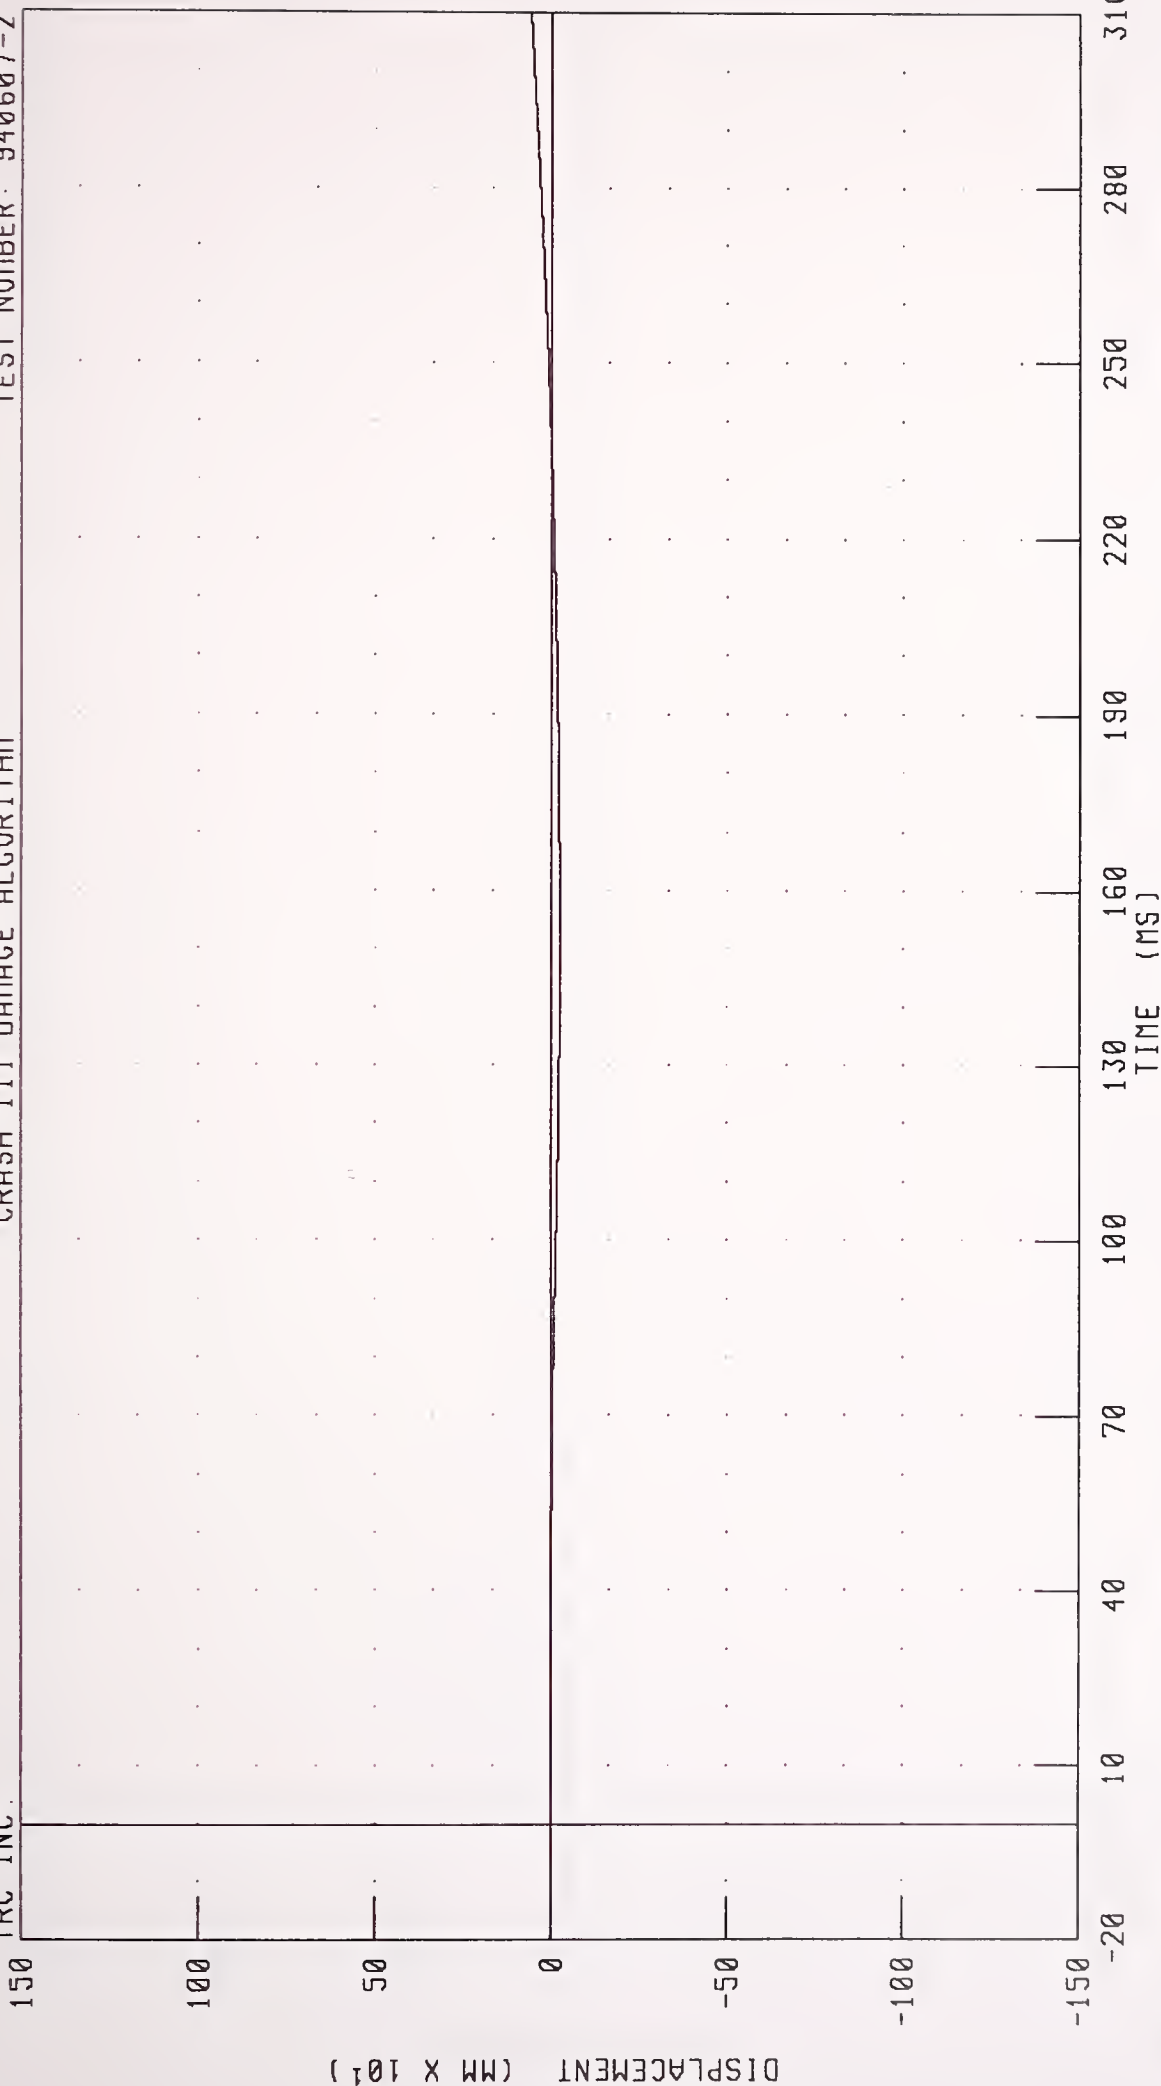
CHANNEL: LRSYD1 FILTER: CH. CLASS 180
